International Journal of Orthopaedics Sciences

Finger injury by snap button machine: A case report of an accident with a jeans snap button machine

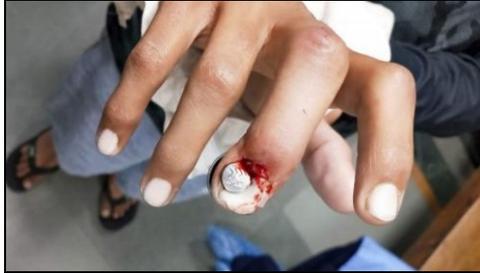
A 16-year-old male was brought to the Emergency Department having pinched his right middle finger in a snap button machine. The accident occurred at a factory while fixing button to a jeans. On closer examination the distal phalanx of his right middle finger was found pinched between two parts of jeans button (Figure 1). The other fingers of the right hand were found free and unharmed. The factory coworkers tried unsuccessfully to cut the button with a side cutter. Considering the unfavourable position of the finger,

Fig 1: Right middle finger nail snapped between jeans button (Dorsal view)

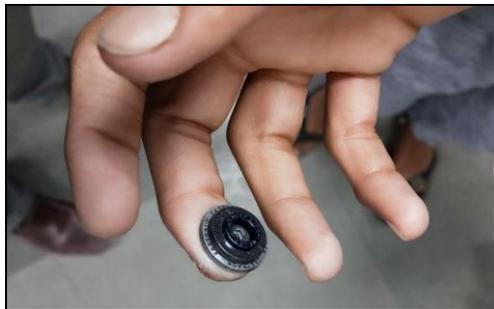
Fig 2: Right middle finger tip snapped between jeans button (Palmar view)

the risk of further damages was too high. Under local anaesthesia we finally succeeded to free the finger by cutting two parts of the button with a wire cutter. Although first impressions of the accident might have expected a worse injury, fortunately it just showed a nail bed cut. There were no bone fractures or tendon injuries found. Peripheral perfusion and sensibility were unimpaired. Under continued local anaesthesia a nail bed suture was performed ^[2] (Figure 2). The forefinger was kept in a special splint for 1 week ^[3].

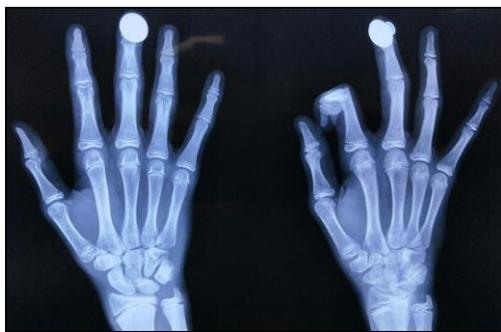
Fig 3: Pre operative x-rays (Antero-posterior and Oblique view) showing jeans button over middle finger distal phalanx

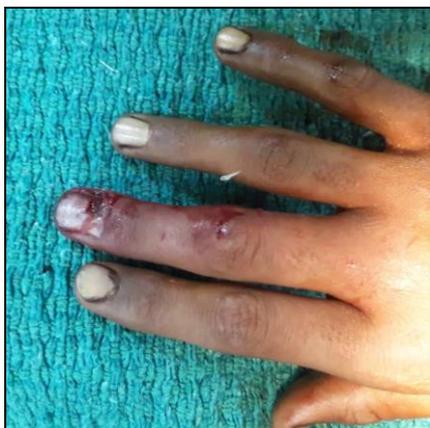
Fig 4: Post operative image showing middle finger after removal of jeans button (Dorsal view)

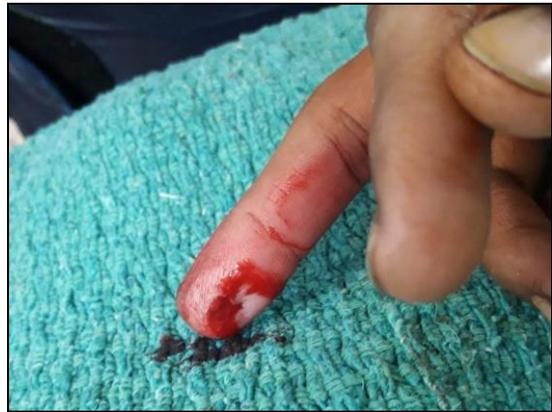
Fig 5: Post operative image showing finger tip after jeans button removal (Palmar view)

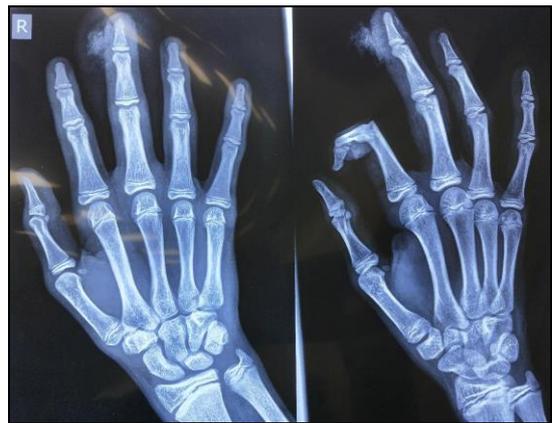
Fig 6: Post operative x-rays (Antero-posterior and Oblique view) after jeans button removal showing middle finger distal phalanx without bony injury

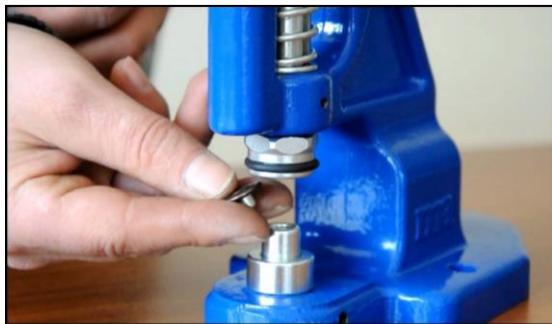
Fig 7: Jeans snap button machine

Most injuries with snap button machine happen due to carelessness. As seen in this case, workers in an attempt to button more jeans in limited time period, while speeding they unconsciously crush their finger in the snapping machine.

In principle, all attempts should be avoided to put fingers between snapping machine while working with it. The safety precautions in old devices are often much too low. Timely intervention is of utmost importance as delayed presentation can lead to appearance of gangrenous changes in digit and subsequent amputation of digit. As long as manual buttoning is still in use, injurie like in this case are to be expected.

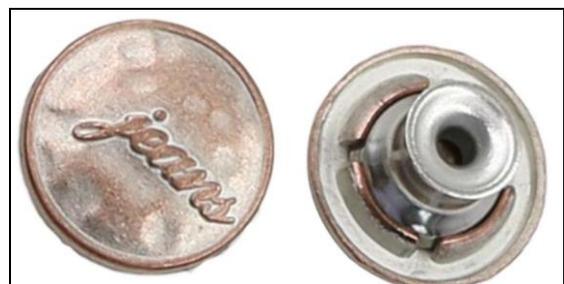
Fig 8: Two parts of Jeans button
