## International Journal of Orthopaedics Sciences

IJOS 2020; 6(1): 1161-1163

### Removal of poly-axial pedicular screw with fractured screw driver slot

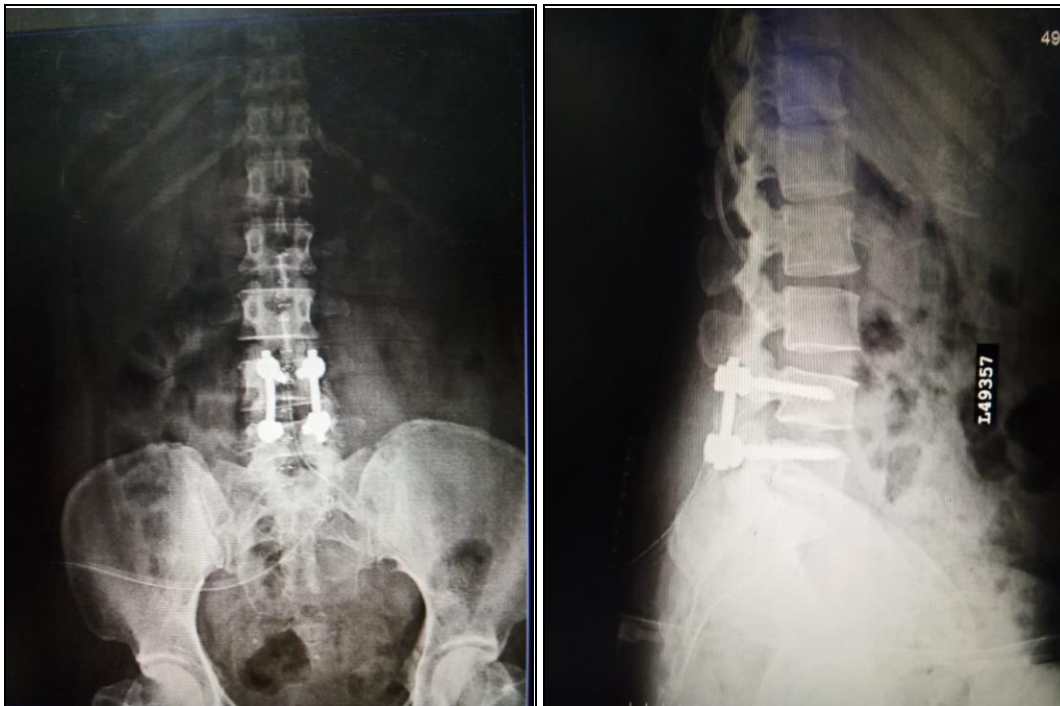
**Fig 1:** Radiograph (AP and Lateral) of Lumbosacral spine

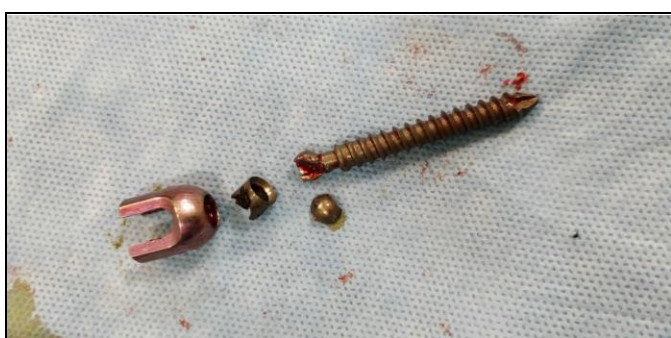
**Fig 3:** Broken pedicular screw with its dismantled polyaxial components

A 48 year old patient had under gone discectomy and posterolateral instrumented fusion of the lumbar spine for L4L5 prolapse of intervertebral disc in 2016. She presented in 2019 with right lower limb radiculopathy, foot drop and reduced sensation in the first web space of the right foot, suggestive of L5 nerve root lesion. On radiography, malposition of the right sided pedicular screws was noted in the 4<sup>th</sup> and 5<sup>th</sup> lumbar vertebrae on the right side. Subsequent MRI showed impingement of the spinal canal by the pedicular screws on the right side. Patient was taken for implant removal. The lumbar spine was exposed using a midline incision and subperiosteal reflection of the paraspinal muscles to expose the pedicular screw heads. Top screws were removed with the corresponding screw driver. The connecting rods were removed. Both left sided screws and right L5 screws were removed with the corresponding locking polyaxial screwdriver. In the right L4 screw, the screwdriver and the polyaxial head component were found to be rotating in place as the screwdriver was unable to engage the slot in the screw head. The head of the screw was found to be split, preventing the screwdriver head from engaging its slot on the screw. We proceeded to dismantle the polyaxial tulip assembly by dislodging the inner ring coupling the polyaxial component and the screw, over the broken screw head using a 5mm curved Osteotome inserted between the inner ring and broken screw head. The fragment of the screw head was removed. The polyaxial head was then removed with a plier to expose the broken screw head. The head was grasped with a plier and the screw rotated counter-clockwise to remove the screw from the pedicle without damaging it.

In our case, the fractured head prevented the screwdriver for engaging the head, allowing the screwdriver, coupled to the polyaxial tulip the rotate freely but the screw remained anchored in the bone as the tip of the screwdriver failed to engage in its slot. Dismantling the screw components allowed for removal of the screw without damaging the pedicle.
