E-ISSN: 2395-1958  
P-ISSN: 2706-6630  
IJOS 2020; 6(2): 538-540  
© 2020 IJOS  
[www.orthopaper.com](http://www.orthopaper.com)  
Received: 04-02-2020  
Accepted: 07-03-2020

## Retrospective observation of complications of radial head replacement

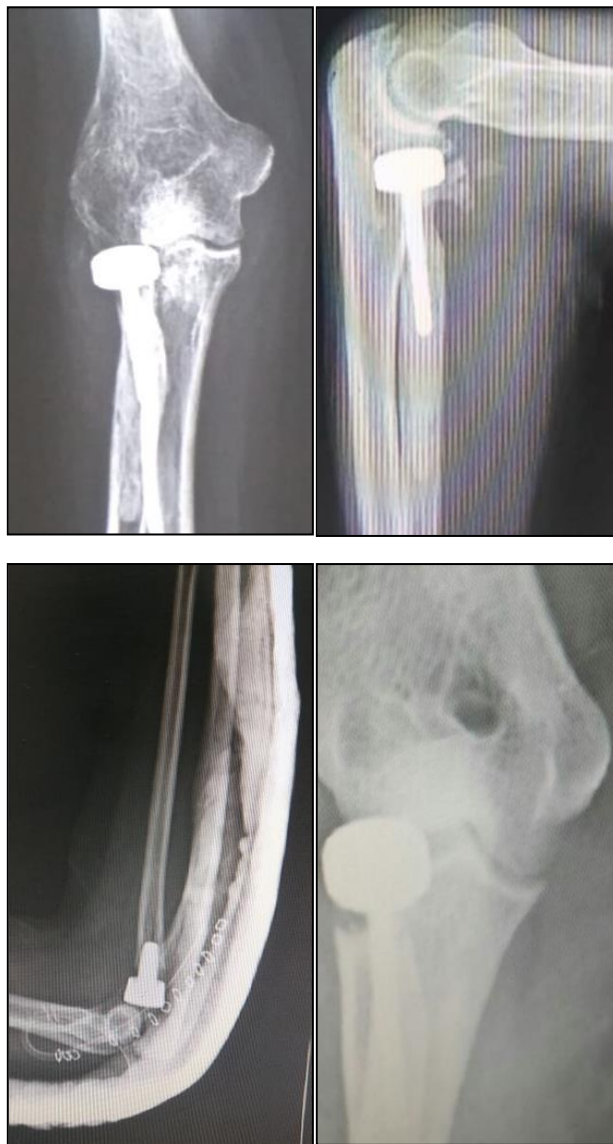
To conclude, overstuffing may lead to a painful elbow. Radiological evaluation intraoperatively may be considered to check the implant position, in order to avoid any overstuffing. 56 year old male operated with the radial head replacement with follow up after 1 month

We observed overstuffing with radial head replacement on radiological analysis in 2 out of 4 patients (Figure 2 a,b). One patient with overstuffing had restriction of elbow flexion to 90°. Both patients with overstuffing had a painful elbow
